From a
GREAT HEIGHT
Helicopter Recovery at Takur Ghar

Abstract: *The 4-5 March 2002 Battle of Takur Ghar in Afghanistan resulted in two downed MH-47E Chinook helicopters. Only one, tail number 476, was salvageable. However, it was in an extremely remote and contested area, factors that complicated a recovery. With considerable planning and the use of a contracted airframe, aviation maintenance soldiers from 2nd Battalion, 160th Special Operations Aviation Regiment recovered the helicopter, allowing it to return to service.*

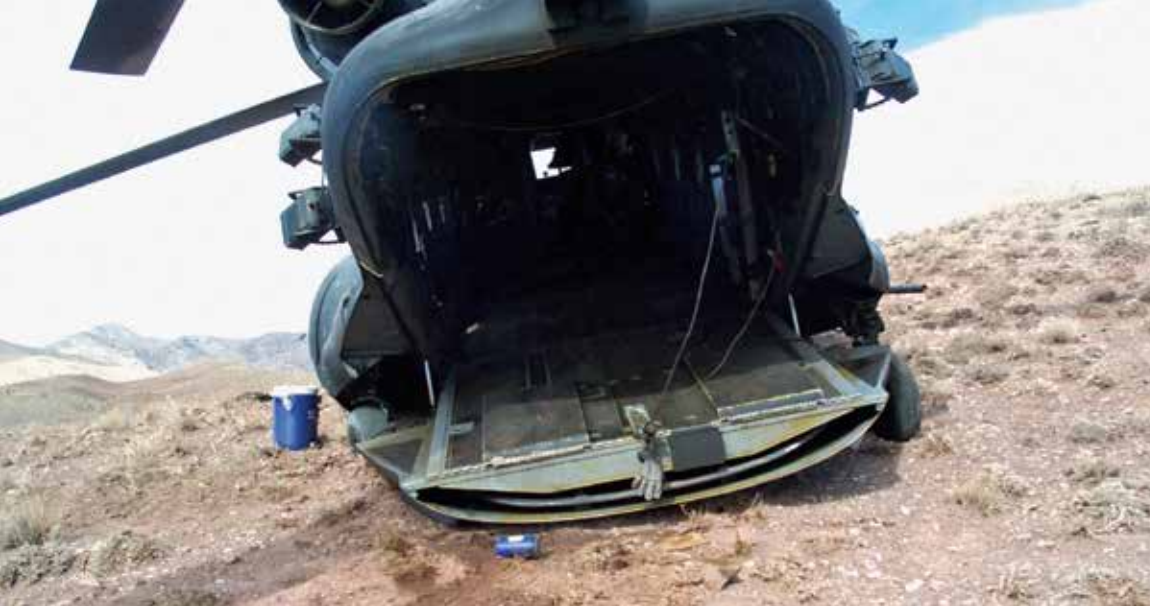
Top: The rear of 476. The glove tied to the ramp was placed there by the SEAL team as a marker to help determine if the helicopter had been tampered with. If the glove was removed, it was a sure sign that someone else had been there.

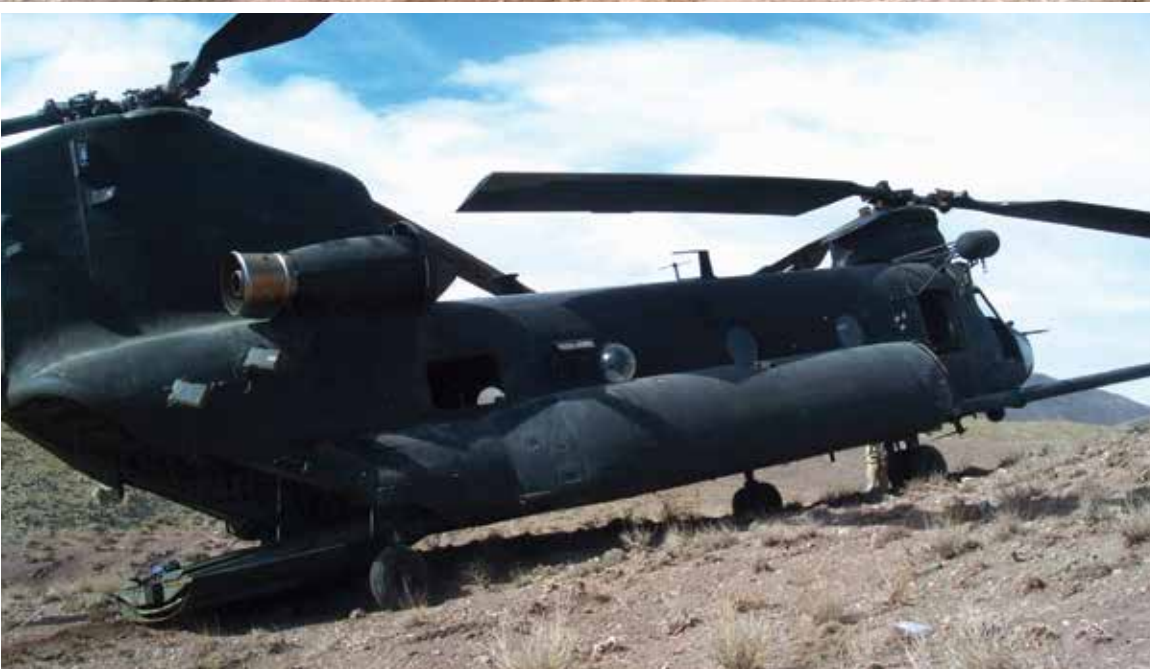
Center: The initial view of 476 as seen by the assessment team. At first glance, the helicopter does not appear to have sustained much damage.

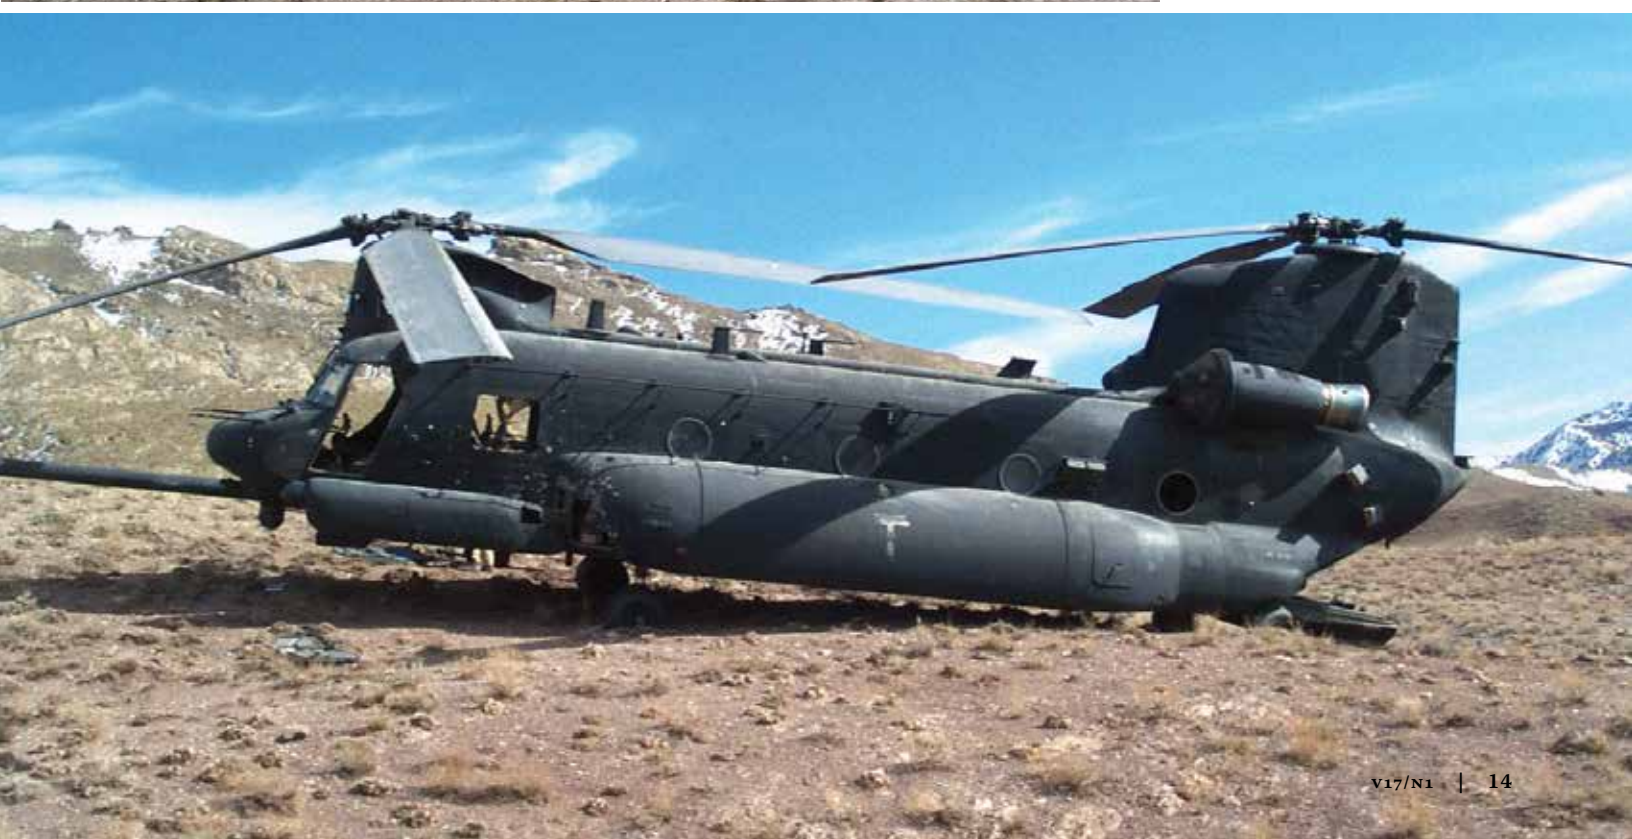
Bottom: The other side of 476 displayed much more of the damage that crippled the helicopter. Notice the impact damage to the front, below the window just to the rear of the cockpit.

SSG Stills* recalled that the helicopter was sitting “on a [steep] angle, and we had to watch our step” because slippery hydraulic fluid coated the floor.¹⁰ The three 160th soldiers inspected the aircraft for half-an-hour to determine if it could be made operational with minimal repairs. They found that an RPG impact had destroyed some avionics, sent shrapnel into the rotor blades and electrical system, and caused a fire. CW4 Milch* called it “a complete [and] total electrical nightmare.”¹¹ In addition, a single bullet had severed an oil line and completely drained the fluid from the rear rotor transmission. The assessment team could not determine if the MH-47E had operated without oil. The situation was potentially fatal if the helicopter tried to fly and the transmission “locked up” in flight, explained Katz.*¹² CW4 Milch* assessed, “There was so much damage we were surprised the aircraft continued flying” during the

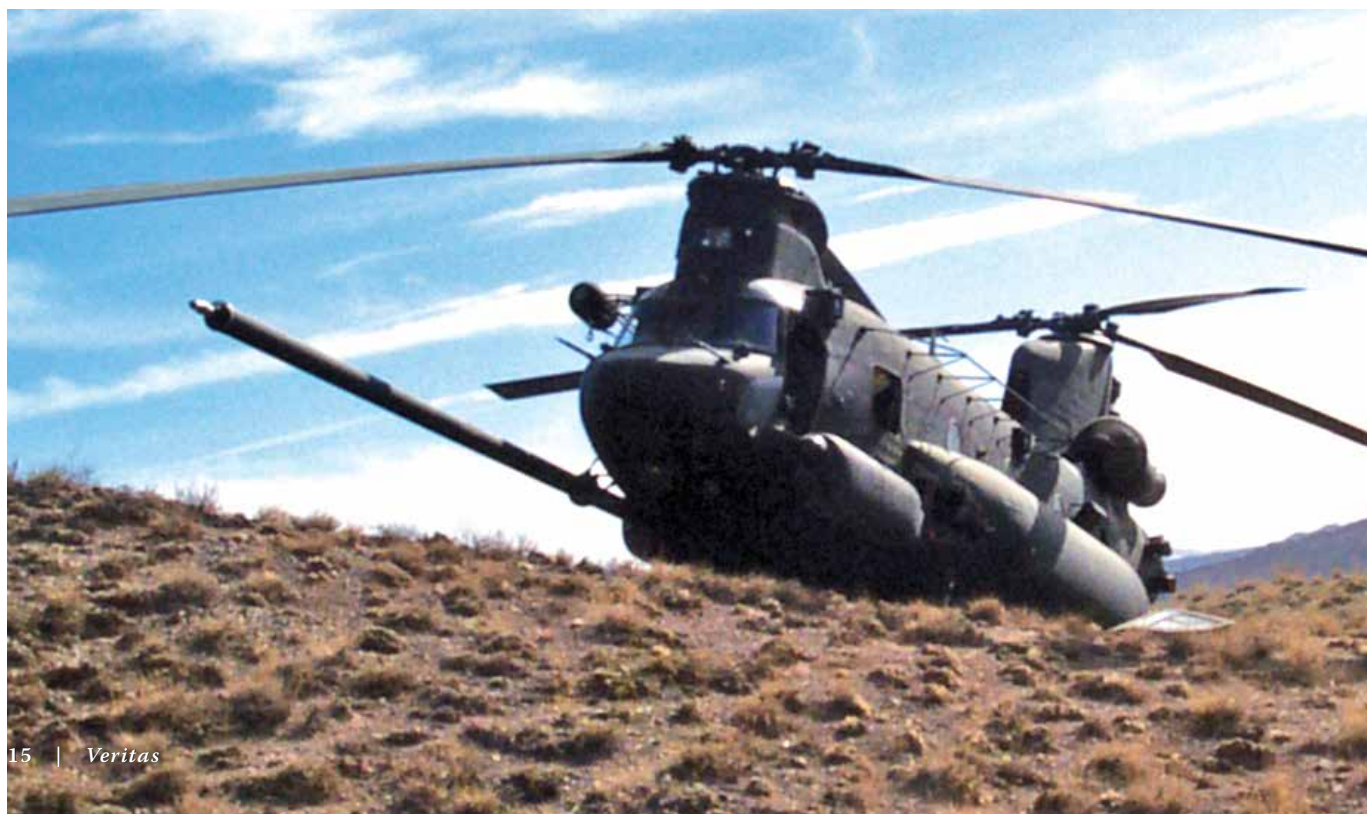
Tail number 476 set down several kilometers from Takur Ghar. It suffered considerable damage and was no longer in a flyable condition, but it was recoverable.

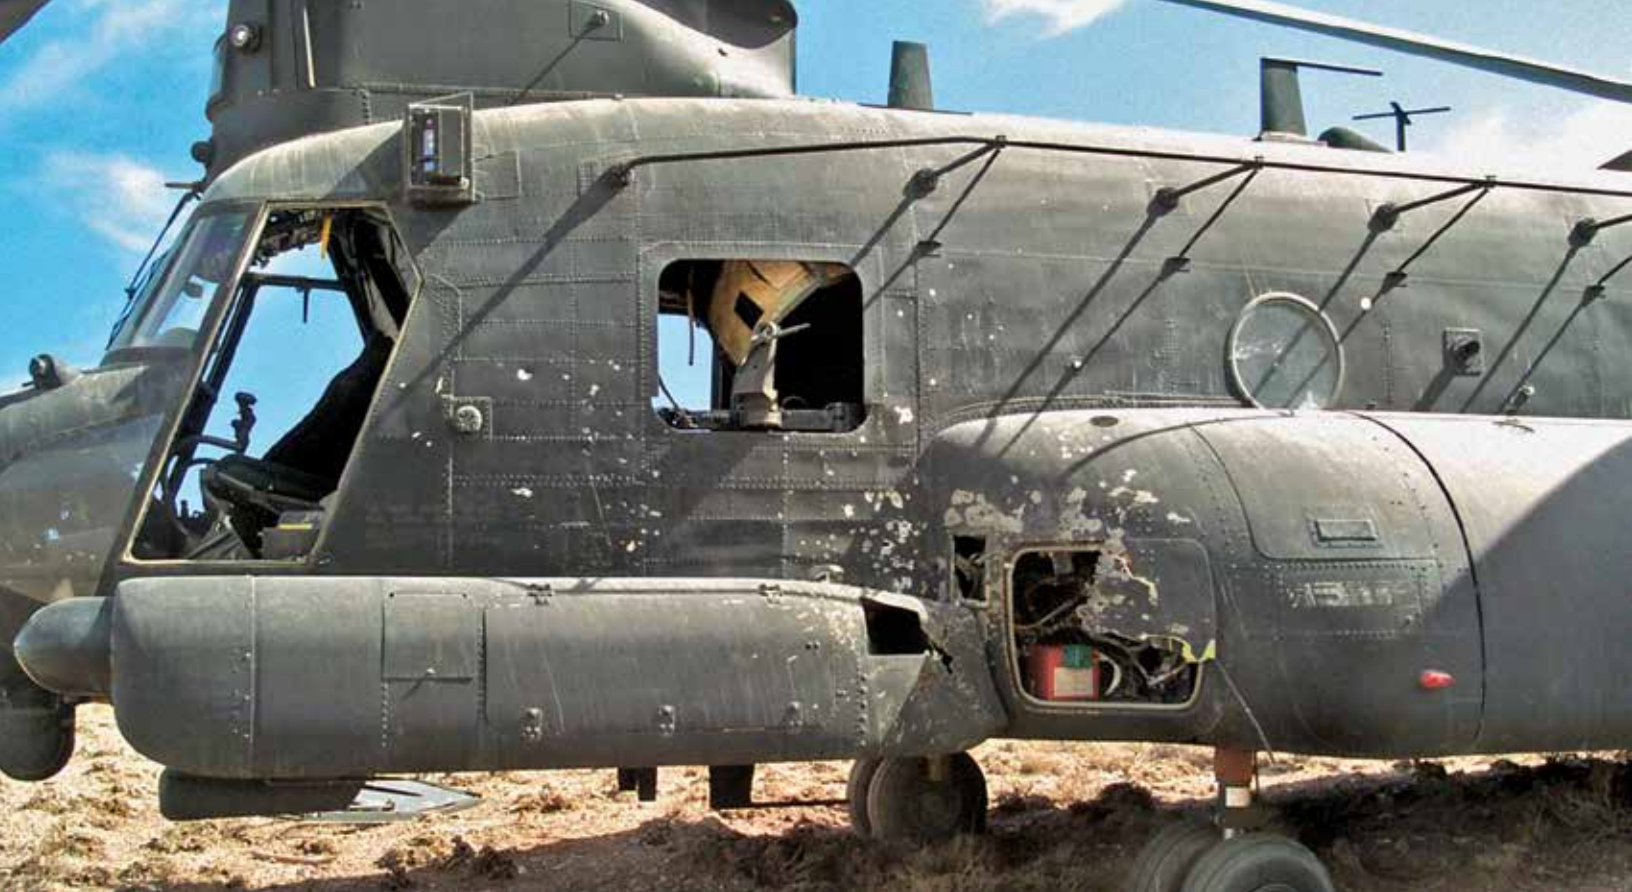
Top: A close up view of the damage to the front of 476. The RPG had exploded on the outside of the helicopter, and started a fire that affected the electrical system. The areas where the paint has been chipped are shrapnel impact points.

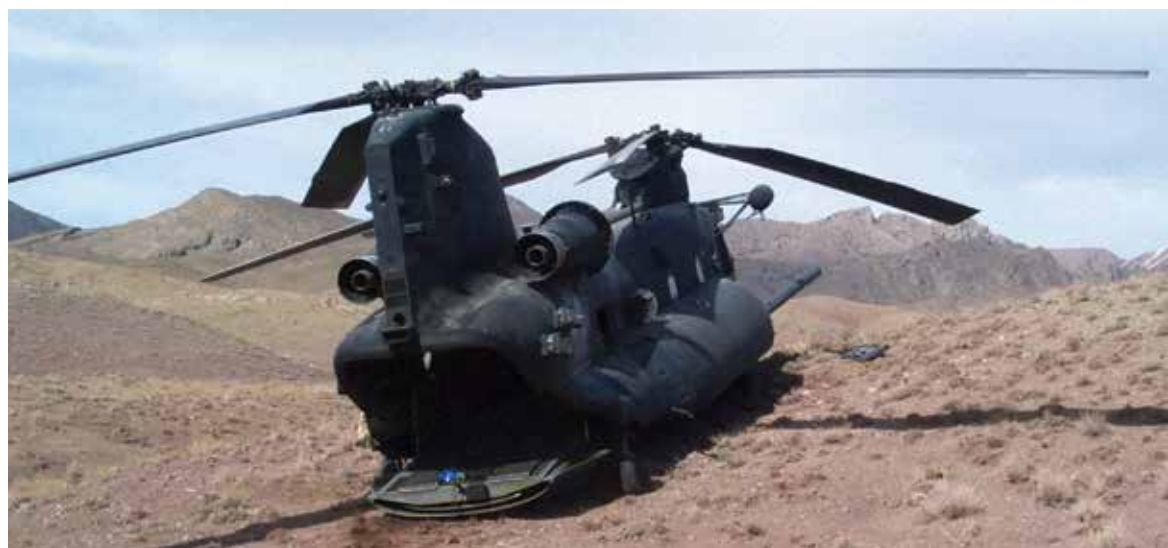
Center: 476 landed at an angle. When combined with slippery hydraulic fluid that covered the floor, it made work difficult for the recovery crew.

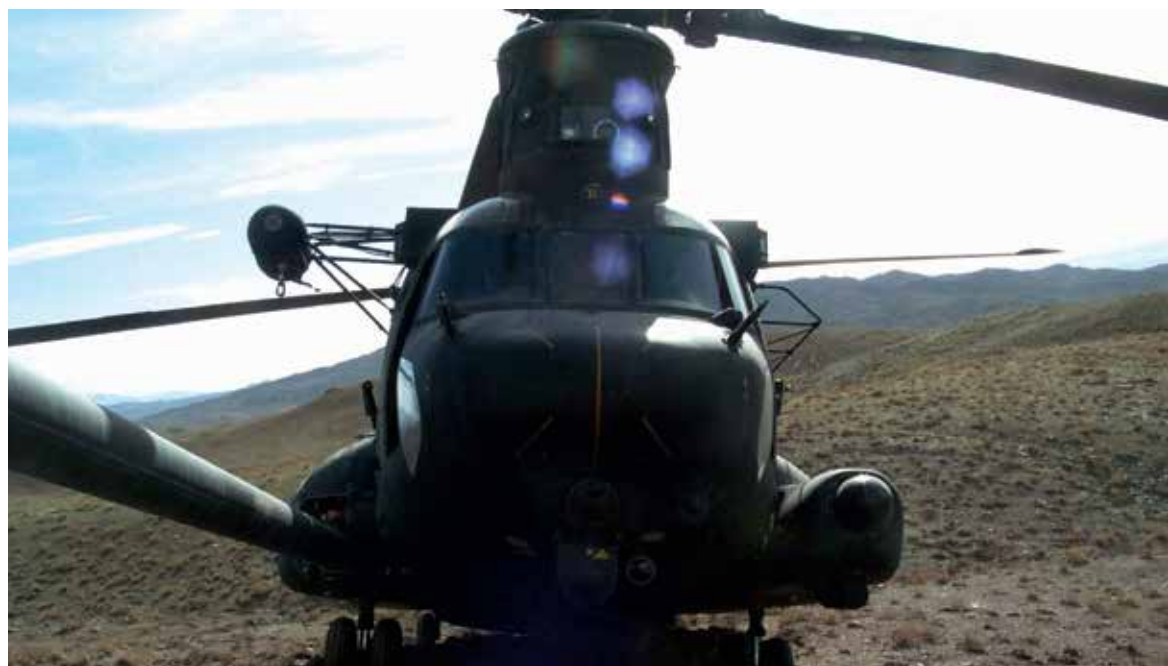
Bottom: The front view of 476. This photo further illustrates the angle at which the damaged helicopter had landed.

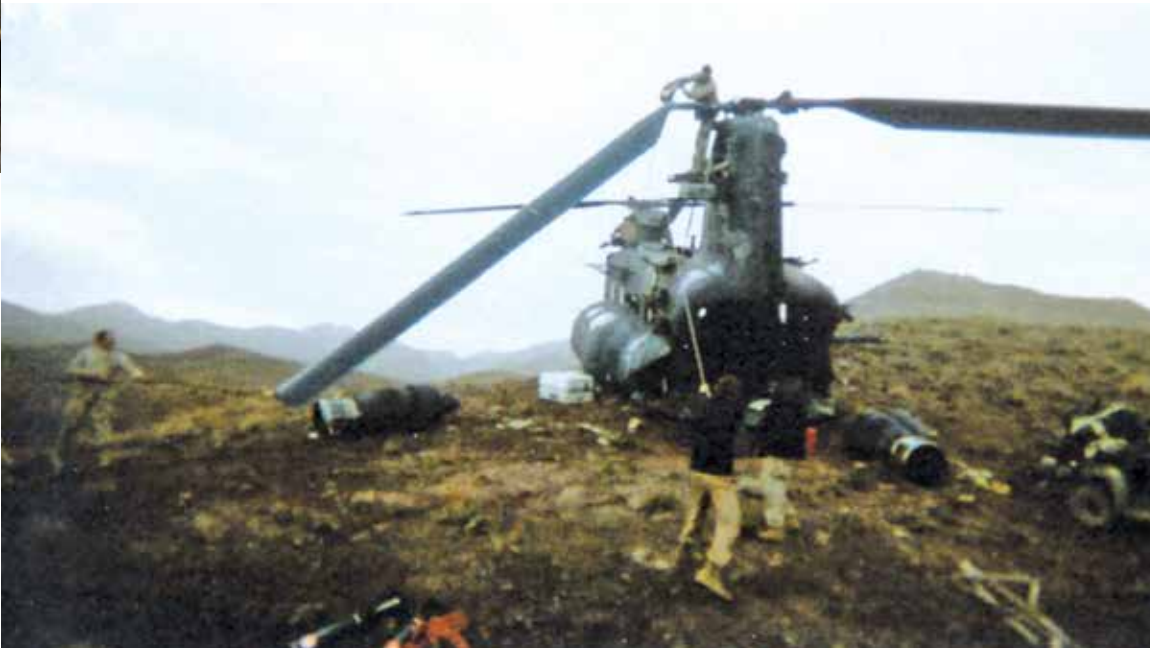
Left: The recovery crew at work cutting the rear rotor blades. Cutting them proved problematic and time-consuming when the blades bent down, forcing the crew to work them back and forth to help break them away.

The team next turned their attention to cutting the rotor blades from underneath with a rescue saw. This worked well until the blades were nearly cut through. When only a few strands of material remained, the blades bent to the ground. The angle made completing the cut difficult, so the recovery team twisted the blades back and forth to break them free. The technique was less than ideal, and one blade struck the airframe, putting a gash in the exterior. Once the last rear blade was cut at 0220 hours, the team radioed for the Mi-26 to proceed. With two 160th soldiers on board, it flew to the crash site.

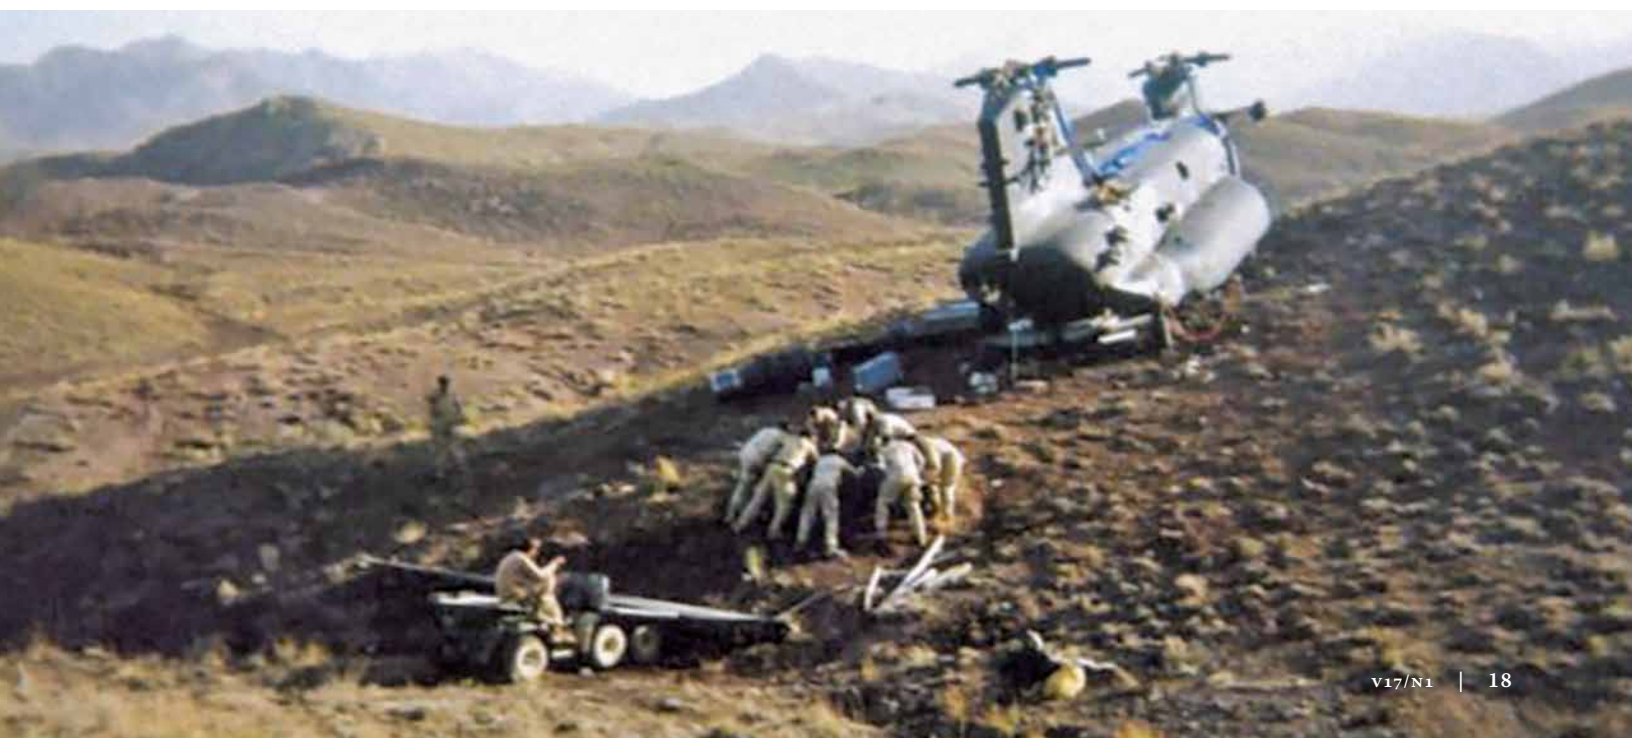
Bottom: Physically lifting the engines proved to be too much for the exhausted recovery crew, who had been working at high altitude for hours. They ingeniously used the Gator and the cut rotor blades to roll an engine into the back of the vehicle. Unfortunately, once on the Gator, they did not have the strength to lift it out, meaning that only one engine was recovered.

The engines proved to be the most difficult items to relocate to a central collection point. The mechanics hoped to lift the engine into the back of the single John Deere Gator all-terrain utility vehicle that the recovery team had brought with them. However, fatigue having set in, no matter how hard they tried, the soldiers could not wrestle the engine into the back of the Gator. Their ingenious solution to the problem was to park the Gator downhill, use the severed rotors as ramps, and roll the engine into the back. Once accomplished, the team realized that it could not get the first engine out of the back

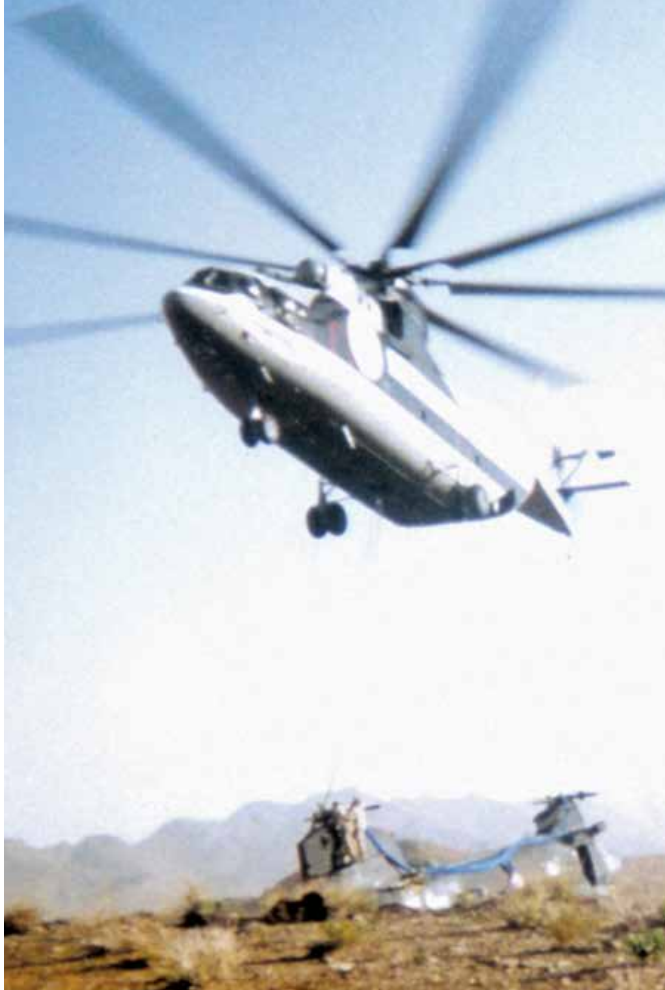
The Mi-26 as it prepared to sling load 476. Notice CW4 Milch* and CW3 Katz* on the rear, both of whom were lifted into the air and had to jump off the rising airframe.

CW4 Milch* and CW3 Katz* climbed on 476 to hook up the slings from the hovering Mi-26. Katz* remembered that the rotor wash was “like a hurricane.”²³ The Mi-26 effortlessly lifted the Chinook, so much that the two found themselves quickly ascending, forcing them to jump about eight feet down to the ground. The Mi-26 easily handled the load and made it the approximately fifteen miles to Gardez for a refueling from 101st Airborne Division CH-47Ds. The Mi-26 set 476 down, detached the straps, and then landed alongside the 101st Chinook.

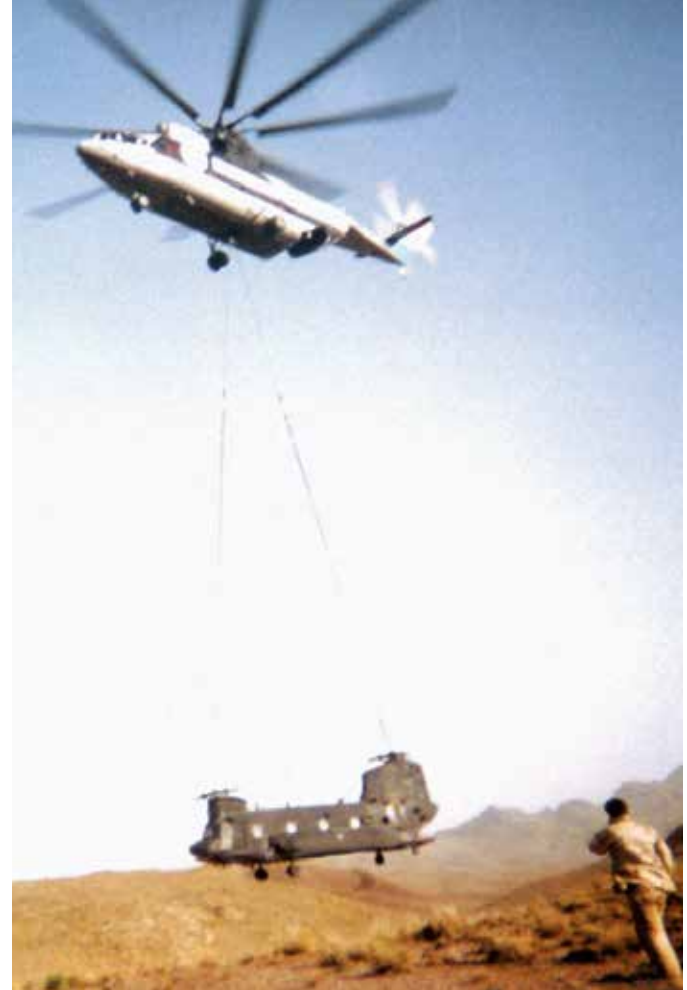
The Mi-26 lifts 476 from its crash site. Once it left, the maintenance crew followed in another Chinook.
